Igniter/Flame Rod Service Instructions

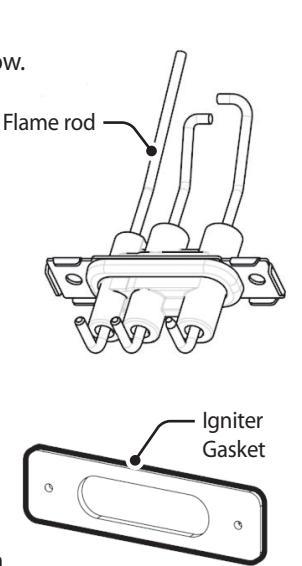
Ignition failure can occur when there is buildup of dirt or white powder. If ignition failure continuously occurs, service the flame rod as shown below.

- 1. Turn off the power to the unit.
- 2. Remove the Igniter.
- 3. Clean the flame rod with an emery cloth. Note the white powdery residue on the sensor.
- 4. Reinstall the Igniter. When reinstalling it, you must replace the Igniter gasket with a new one.

5. Turn on the power to the unit and check the ignition during operation.

If ignition failure continues, contact Navien Technical Support at 1-800-519-8794.
